## COMET MAST HOLE July 2023 Andy Simmons.

With the vast majority of Comets being built way back in the late 80's and into the 90's we are beginning to see a few age-related problems on some of these older Comets.

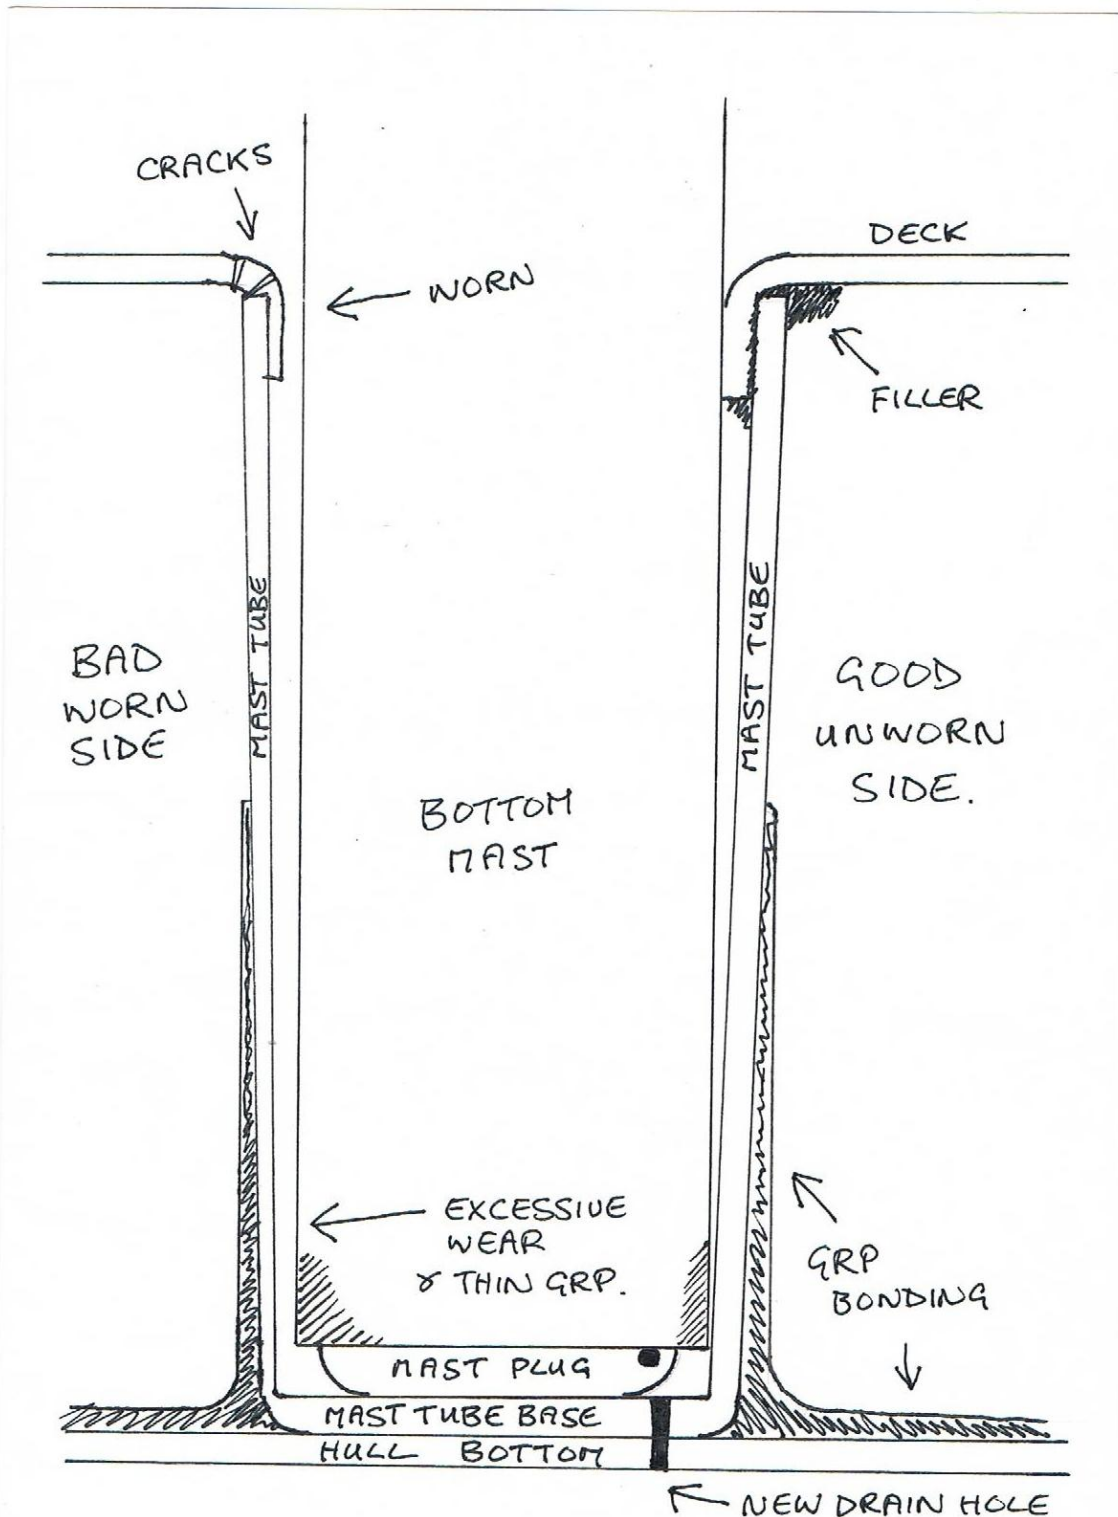
The most important one of these is the mast hole at the deck and the bottom of the mast tube. The drawing shows a cross section of the mast tube in a Comet. It's actual size in width but not in height! One half shows, in theory, how it is when new, the other shows how it wears.

Depending on how clean the mast tube is kept, the mast will always wear through the anodizing at the bottom and around the deck hole area. This shouldn't cause alarm as the metal mast tube is 4mm thick. If a Comet is here for repair and even if the mast deck hole isn't damaged, I will often paint a new coat of gelcoat around the deck hole if it looks worn with the GRP showing instead of gelcoat. This sometimes needs a bit of sanding to get the mast back in! Don't forget there will always be a bit of play as the unworn part of the mast has to go through.

Even if the deck hole looks fine, it's a good idea to check the wear at the bottom of the mast tube as serious wear here can have disastrous results! Basically, the mast wears the GRP tube so thin that the tube becomes detached from the bottom of the hull and the mast tilts over maybe 10 or 20 degrees causing a lot of damage to the deck.

To repair this, you can pour a small amount of gelcoat resin neatly down the middle of the mast tube trying not to get it on the sides. This makes a new mast base (put a bit of masking tape on the hull if you actually have a hole through).

Use a 1" "throwaway" paint brush taped to the stick to paint a thin coat a couple of inches up the sides of the tube. Ideally this renews the bottom of the mast tube taking away most of the play and delaying further wear.
